Town of Arlington, Massachusetts

PART A – Executive Summary Self- Evaluation and Transition Plan

November 2019

Part A – Executive Summary

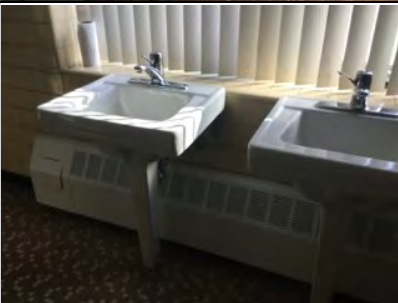
Toe or knee clearances not provided	-	Provide at least one lavatory with knee and toe clearance positioned for a forward approach.	1	843	\$843
12	Annex, Toilet Room in Planning Offices	1		Dispensers	Paper Towel Dispenser

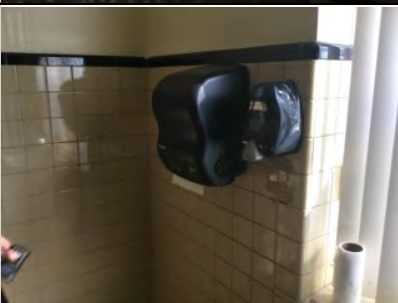
Controls > 42" high Not operable with a closed fist Dispenser acts as a protruding object	43.5" - 9'	Relocate paper towel dispenser so the operable part is 42" max. above the finish floor. Provide a dispenser that can be operable with one hand and not require tight grasping, pinching, or twisting of the wrist. Relocate dispenser out of the circulation path.	1	823	\$823

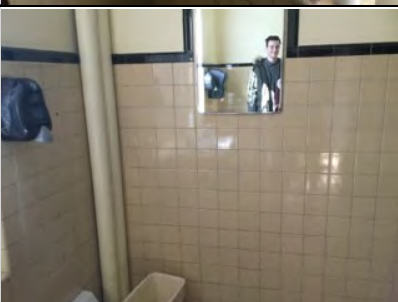
13	Annex, Toilet Room in Planning Offices	1		Lavatory	N/A

Mirror above lavatory w/reflective surface > 40"	49"	Lower mirror so that the bottom surface is at 40" max. above finish floor.	1	128	\$128
14	Annex, Toilet Room in Planning Offices	1		Urinal	N/A

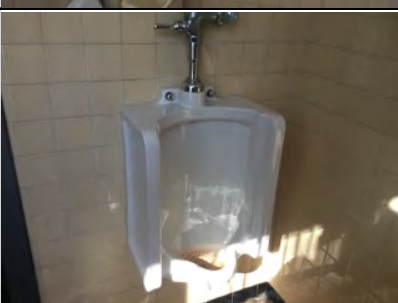
Rim > 17" high Flush control is > 44" high or not properly located	23" 51.5"	Provide at least one urinal with the rim no higher than 17" above the finish floor. Mount flush control at 44" max. above the finish floor.	1	1811	\$1811

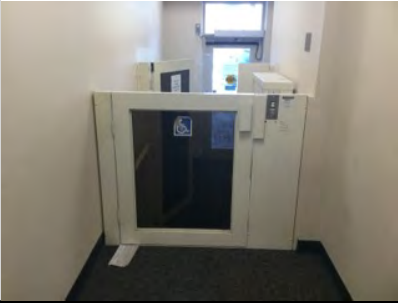
Not independently operable	-	On the initial day of survey, the lift was not operable because the bottom door was left open. Ensure the lift is maintained and functional.	1	Labor	\$0
Access to Goods and Services												
16	Annex,Elevator	1		Elevator	Interior

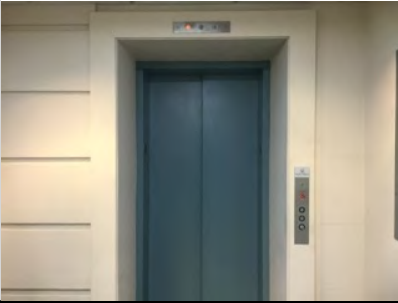
Elevator car control > 48"	57"	Car controls insidethe elevator are located at 57" high. Relocate control panel so the highest control is 48" or lower. Ensure button lights work.	1	17550	\$17550
Access to Goods and Services												
17	Assessor's Office	1		Signage	Designation

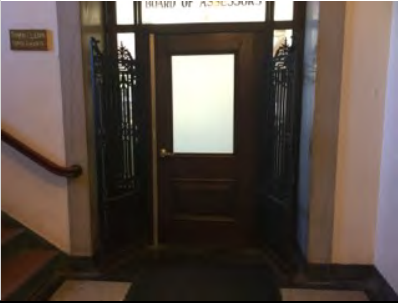
Raised characters not provided Braille not provided		Provide text with raised characters duplicated in braille.	1	116	\$116

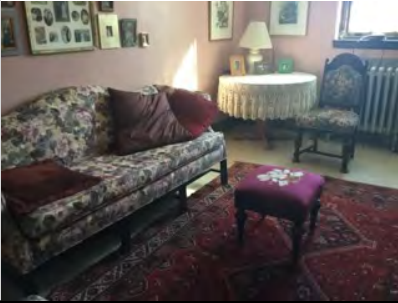
Access to Goods and Services												
18	Bridal Room	1		Doors, Doorways, & Gates	Other

Mat not securely attached	-	Secure the rug.	1	Labor	\$0
19	Bridal Room	1		Doors, Doorways, & Gates	Other

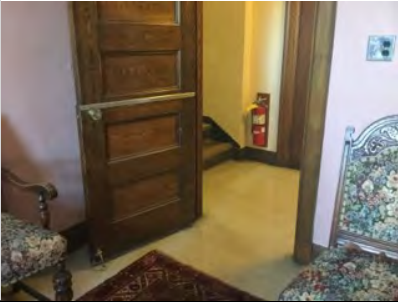
Hardware not operable with a closed fist	-	Provide hardware that can be operable with one hand and not require tight grasping, pinching, or twisting of the wrist.	1	242	\$242

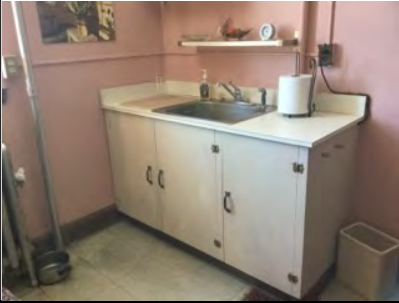
Toe and knee clearances not provided	-	Ensure there is a 27" knee clearance positioned for a forward approach.	1	843	\$843
Approach and Entrance												
21	Massachusetts Avenue Sidewalk by Academy Street	1		Exterior Access Route	Sidewalk

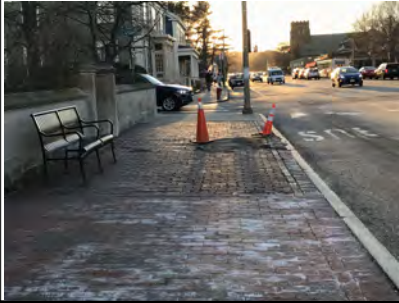
Route not maintained in operable working condition		Ensure the sidewalk is maintained in operable working condition. Level and reset bricks.	1	440	\$440
Access to Goods and Services												
22	Route From Planning Conference Room to Stage	1		Doors, Doorways, & Gates	Circulation

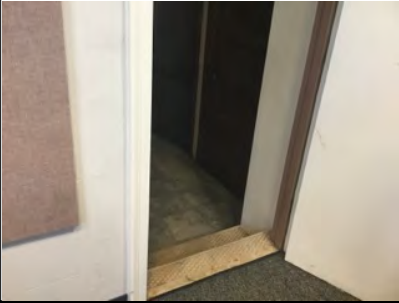
Clear width at door < 32"	30"	Use offset hinges to ensure the door has a clear width of 32" minimum.	1	1116	\$1116
Best Practice												
23	Town Hall Main Entrance Lobby	1

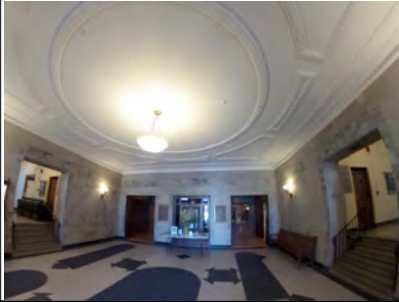
Wayfinding: The main entrance lobby has no informational or directional signage about the location of the auditorium, Annex, offices and meeting rooms. Consider providing wayfinding signage at this point and clearer signage denoting the location of the elevator. In addition, information should be provided about the accessible route to the Annex, Assessor's Office and Treasurer's Office.	1		\$0

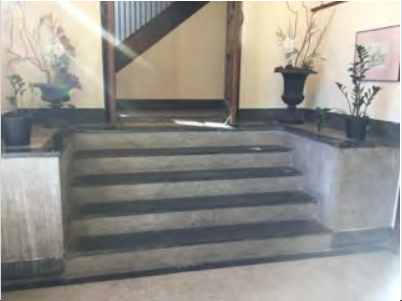
-	Stair: Consider providing at least one handrail.	2		\$0
Best Practice												
25	Town Hall, Accessible Route To Board of Assessors	1

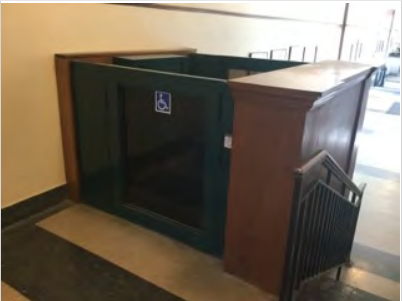
-	Wayfinding: Consider providing directional signage at the lift indicating the accessible route and where it leads (destination points).	1		\$0
Best Practice												
26	Town Hall, Accessible Route To Treasurer	1

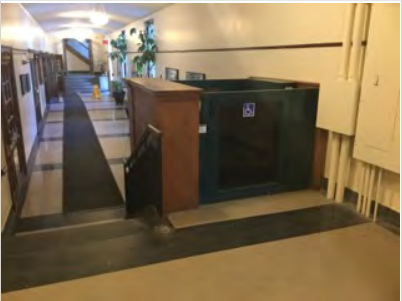
-	Wayfinding: Consider providing directional signage at the lift indicating the accessible route and where it leads (destination points).	1		\$0
Access to Goods and Services												
27	Town Hall, Accessible Toilet Room	1		Signage	Designation

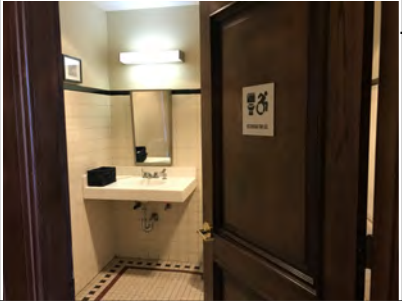
Sign not located on the latch side of the door		Locate sign at permanent rooms alongside the door on the latch side.	1	Labor	\$0

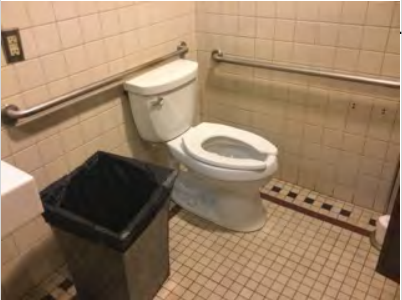
28	Town Hall, Accessible Toilet Room	1		Operable Parts	Other

Reach < 15" or > 48"(forward/side approach)	- -	Relocate toilet paper to be between 15"- 48" above finish floor. Best Practice: Provide a toilet paper dispenser.	1	Labor	\$0

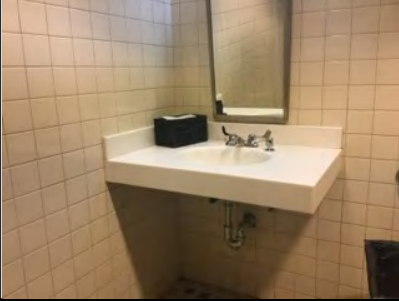
Plumbing underneath is exposed	-	Insulate or otherwise configure pipes to prevent contact at lavatory.	1	46	\$46
30	Town Hall, Accessible Toilet Room	1		Single-User Toilet	N/A

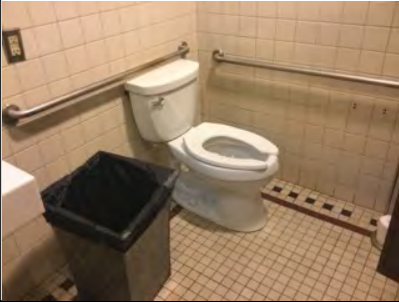
Clearance at toilet < 60" clear width	- -	Provide a clear floor space that is 60" wide min. at the toilet. Relocate trash can.	1	Labor	\$0
Access to Goods and Services												
31	Town Hall, Board Of Assessors Office	1		Service Counter	N/A

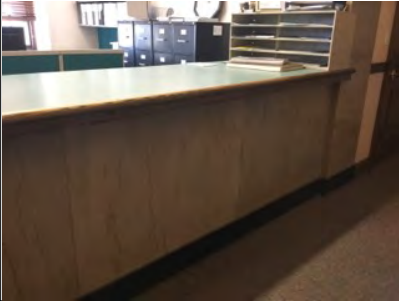
Counter > 36" high	40"	Provide a counter that is 36" max. above the ground or finished floor.	1	440	\$440
32	Town Hall, Board Of Assessors Office	1		Dining or Work Surfaces	Work Surface

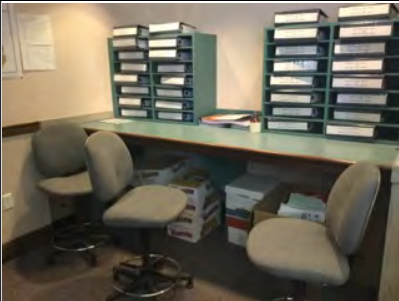
Top of dining/work surface < 28" or > 34"	37"	Provide at least 1 work surface with tops between 28"- 34" above the floor and 27" clear height underneath.	1	350	\$350

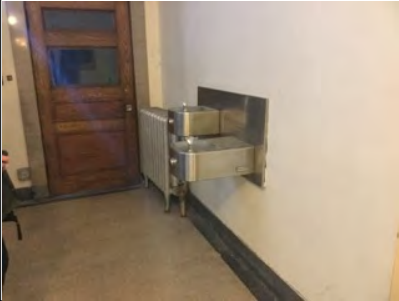
Additional Access												
33	Town Hall, Corridor Near Treasurer	1		Drinking Fountains	Hi-Lo

Inadequate water flow Standing height fountain does not have cane protection	- -	Repair drinking fountain to provide adequate water flow. Provide a cane-detectable barrier skirt under the high unit.	1	445	\$445

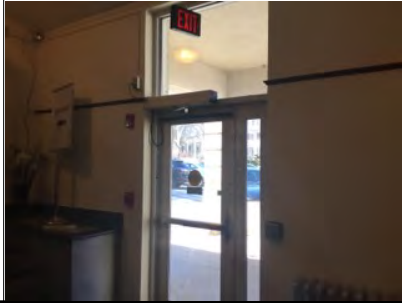
Tactile exit sign not provided	- -	Ensure tactile exit signs with raised characters and braille are provided at exit doors. Mount signs between 48"- 60" above finish floor located on the latch side of the door.	2	116	\$232
Access to Goods and Services												
35	Town Hall, Front Hall	1		Doors, Doorways, & Gates	N/A

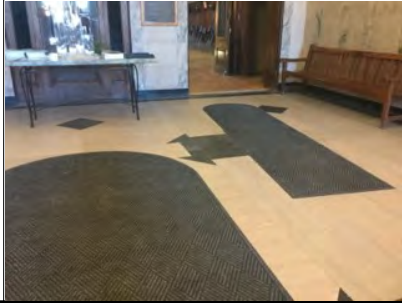
Mat not securely attached	-	Secure the mats.	5	Labor	\$0
Access to Goods and Services												
36	Town Hall, Front Toilet Rooms (Men's and Women's Toilet Rooms)	1		Interior Access Route	N/A

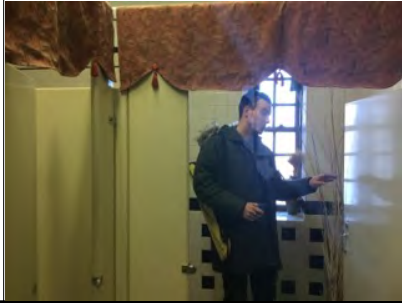
Obstructed by protruding objects	-	Remove drapes in toilet rooms.	2	Labor	\$0
Best Practice												
37	Town Hall, Main Entrance Bench	1

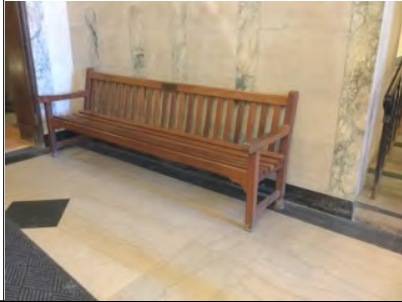
Consider providing clear floor space of 36" wide min. by 48" deep alongside one bench in Town Hall so that a wheelchair user can sit alongside someone sitting on the bench.	1		\$0

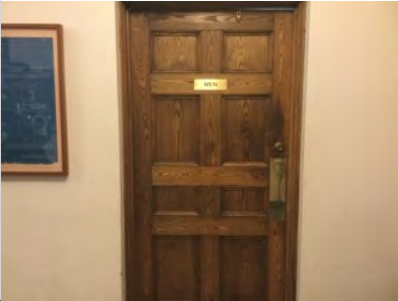
ID	Location	Floor	Room	Element	Type	Photo	Issues	Current Measure	Recommendations	Quantity	Price	Cost Estimation
Access to Goods and Services												
38	Town Hall, Men's Toilet Room Near Treasurer	1		Signage	Designation

Raised characters not provided Braille not provided Sign not located on the latch side of the door	- - -	Provide text with raised characters duplicated in braille. Locate sign at permanent rooms alongside the door on the latch side.	1	116	\$116
39	Town Hall, Men's Toilet Room Near Treasurer	1		Doors, Doorways, & Gates	Toilet Room

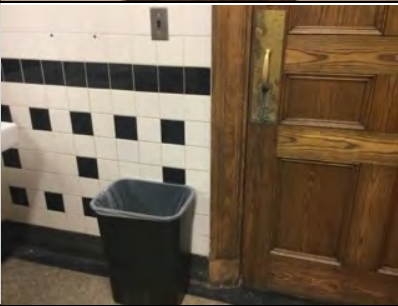
Maneuvering clearance(s) not provided	-	Relocate the trash can away from the latch side of the door.	1	Labor	\$0
Access to Goods and Services												
40	Town Hall, Near Board of Assessors Office	1		Signage	Informational

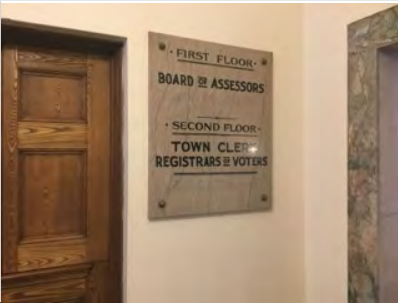
Non glare finish and contrast not provided	- -	Provide signs with a non-glare finish with characters that have a high contrast to the background.	1	116	\$116

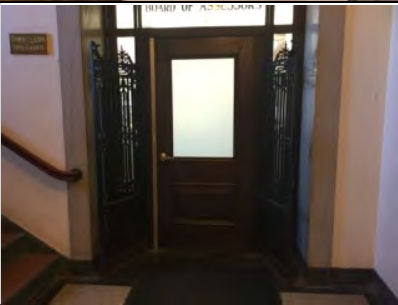
41	Town Hall, Near Board of Assessors Office	1		Doors, Doorways, & Gates	Office

Mat not securely attached	-	Secure the mat.	1	Labor	\$0
Additional Access												
42	Town Hall, Near Board of Assessors Office	1		Drinking Fountains	Hi-Lo

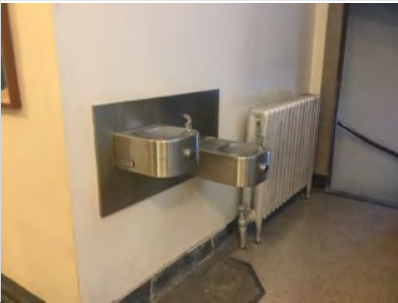
Inadequate water flow Standing height fountain does not have cane protection	- -	Repair drinking fountain to provide adequate water flow. Provide a cane-detectable barrier skirt under the high unit.	1	445	\$445

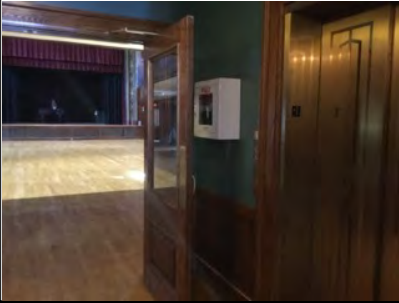
ID	Location	Floor	Room	Element	Type	Photo	Issues	Current Measure	Recommendations	Quantity	Price	Cost Estimation
Access to Goods and Services												
43	Town Hall, Route to Auditorium	1		Interior Access Route	N/A

Obstructed by protruding objects	52.5"	Relocate defibrillator.	1	128	\$128
Access to Goods and Services												
44	Town Hall, Treasurer	1		Service Counter	N/A

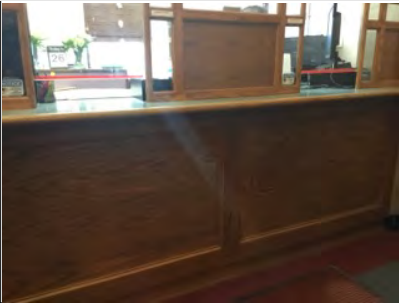
Counter > 36" high	42"	Provide a counter that is 36" max. above the ground or finished floor.	1	440	\$440
45	Town Hall, Treasurer	1		Doors, Doorways, & Gates	Other

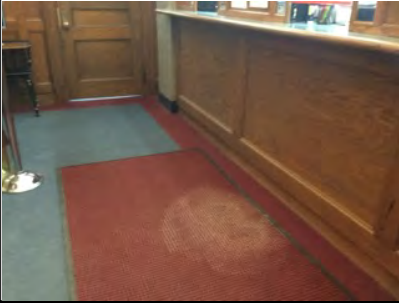
Mat not securely attached	-	Secure the mat.	1	Labor	\$0
46	Town Hall, Treasurer	1		Service Counter	N/A

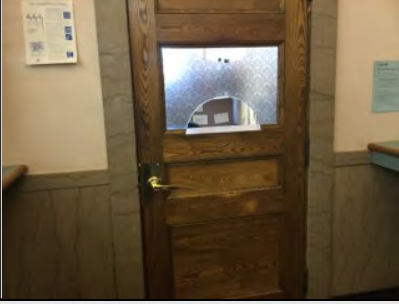
Counter > 36" high	46"	Provide a counter that is 36" max. above the ground or finished floor.	1	440	\$440
Toilet & Bathing Rooms												
47	Town Hall, Women's Toilet Room	1		Toilet Compartment	Accessible Compartment

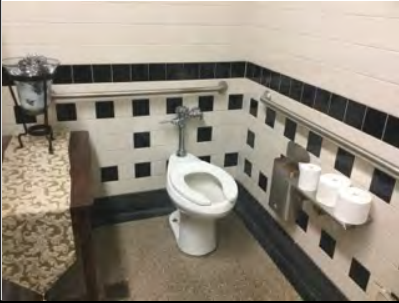
Clearance at toilet < 60" clear width	-	Relocate table out of clear width required at the toilet.	1	Labor	\$0

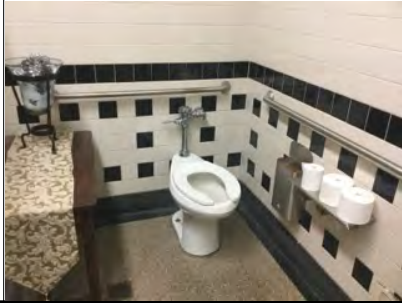
ID	Location	Floor	Room	Element	Type	Photo	Issues	Current Measure	Recommendations	Quantity	Price	Cost Estimation
Best Practice												
48	Town Hall, Women's Toilet Room	1

-	In the toilet rooms on Level 1 of Town Hall, toilet paper dispensers are not provided and toilet paper rolls are located on a shelf. Consider providing toilet paper dispensers, as grabbing and using the toilet paper roll would require grasping and fine motor skills.	1		\$0
Access to Goods and Services												
49	Annex, Stair at Main Entrance (Levels 1-3)	1-3		Stairways	Interior

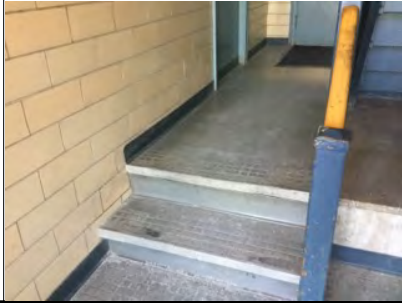
Handrail height < 34" or > 38" Handrail not provided on both sides Handrails do not extend 12" from stairs Handrails not continuous where required	32" - -	Provide a continuous handrail. Ensure it is 34"-38" high above the floor. Ensure extensions are provided - Top: Ensure handrails extend horizontally above the landing for 12" min. beginning above the first riser nosing. Bottom: Ensure handrails extend to one tread depth beyond the last riser. Handrail is not provided on both sides, but the route is so narrow, a second handrail is not recommended.	1	2220	\$2220

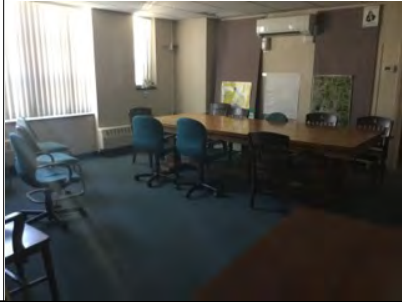
Knee or toe clearance not provided	25"	Provide at least 1 work surface with 27" min. knee and toe clearance.	1	350	\$350

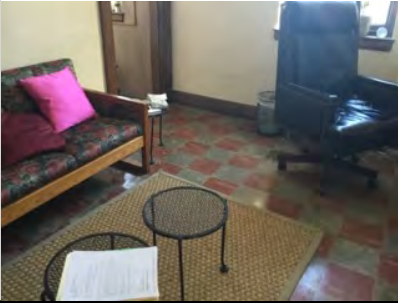
ID	Location	Floor	Room	Element	Type	Photo	Issues	Current Measure	Recommendations	Quantity	Price	Cost Estimation
Access to Goods and Services												
52	Annex, Facilities /Event Office	2		Doors, Doorways, & Gates	Office

Mat not securely attached	-	Secure the rug.	1	Labor	\$0
Access to Goods and Services												
53	Annex, Inaccessible Entrance to Town Manager Purchasing Web Master	2		Doors, Doorways, & Gates	Office

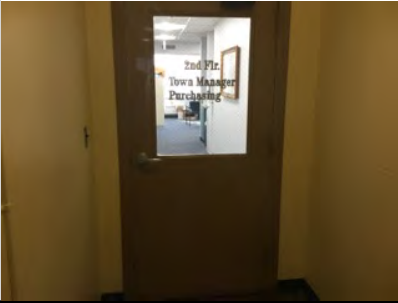
Door requires > 5 lbs. of force to open	14 lbs	Adjust closer so door does not require more than 5 pounds of force to open.	1	Labor	\$0
54	Annex, Inaccessible Entrance to Town Manager Purchasing Web Master	2		Stairways	Interior

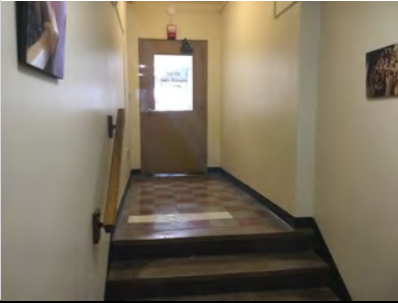
Minimum vertical clearance not provided	73"	Providing the 80" high vertical clearance minimum may be technically infeasible. Consider adding signage that says, "Low Headroom" or, "Low Ceiling".	1	116	\$116
Access to Goods and Services

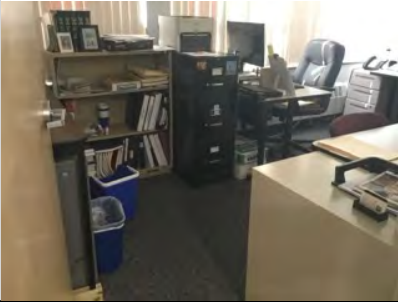
55	Annex, Office of Town Manager Purchasing Web Master	2		Interior Access Route	N/A

Route < 36" wide	27"	Ensure that a clear width of 36" min. is maintained at the accessible route.	1	Labor	\$0
Toilet & Bathing Rooms												
56	Annex, Toilet Room in Facilities/Event Office	2		Overall Access	Toilet Room

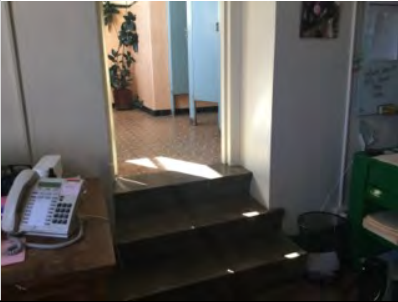
Not on an accessible route Accessible plumbing fixtures or stalls not provided	- -	Provide a directional sign to an accessible toilet room.	1	116	\$116

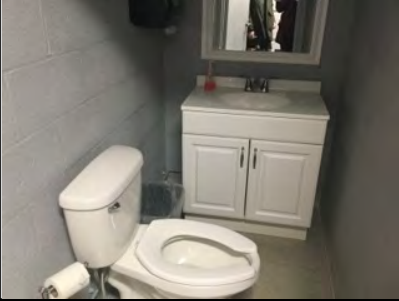
ID	Location	Floor	Room	Element	Type	Photo	Issues	Current Measure	Recommendations	Quantity	Price	Cost Estimation
Access to Goods and Services												
57	Annex, Town Manager Purchasing Web Master Toilet Room	2		Signage	Designation

Directional sign to access. toilet not provided	-	Provide a sign indicating the location of the nearest accessible toilet room.	1	116	\$116
Best Practice												
58	Balcony, Town Hall, Auditorium	2

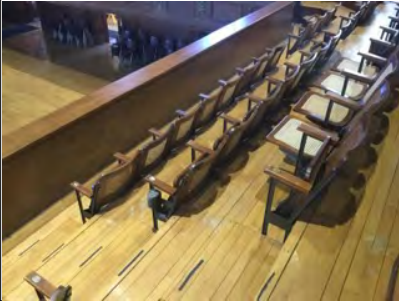
Best Practice: In the balcony, install textured rubber caps on the stair nosings in a contrasting color and add hand holds wherever possible. Consider adding floor level lighting. Work with the Disability Commission to improve safety for visually impaired visitors to the balcony.	1		\$0
Access to Goods and Services												
59	Hearing Room and Auditorium	2		Signage	Designation

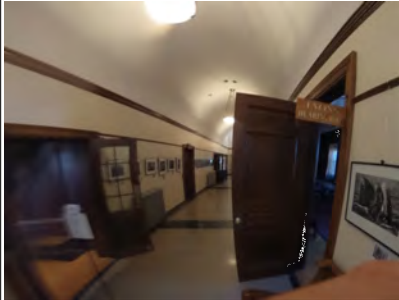
Raised characters not provided Braille not provided		Provide text with raised characters duplicated in braille at auditorium and hearing room doors.	4	116	\$464

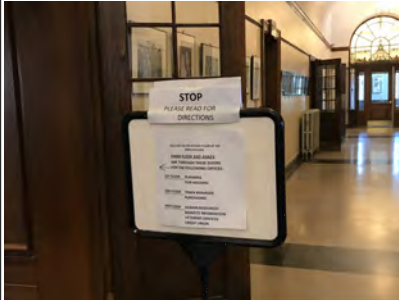
Best Practice												
60	Town Hall, Auditorium Balcony, Directional Sign Denoting Route via Auditorium to the Annex Offices	2

Wayfinding: Consider providing a clearer permanent sign. Consider providing information about the accessible route to these offices (as this route narrows to 24" wide).	1		\$0

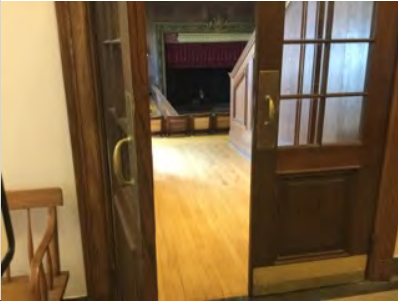
ID	Location	Floor	Room	Element	Type	Photo	Issues	Current Measure	Recommendations	Quantity	Price	Cost Estimation
Access to Goods and Services												
61	Town Hall, Auditorium Balcony From Building Front	2		Doors, Doorways, & Gates	Assembly Space

If double-leaf door, neither compliant	28"	Ensure that at least the active leaf is at least 32" min. wide. (Another option could be to install an automatic door opener that opens both leaves simultaneously.)	1	1683	\$1683
Access to Goods and Services												
62	Town Hall, Corridor Near Town Clerk and Registrar of Voters	2		Interior Access Route	N/A

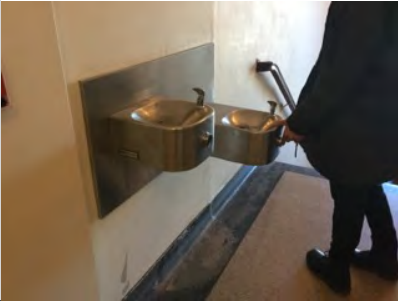
Obstructed by protruding objects	18"	Provide a cane-detectable barrier at high drinking fountain.	1	445	\$445
Access to Goods and Services												
63	Town Hall, Lyons Hearing Room	2		Dining or Work Surfaces	Work Surface

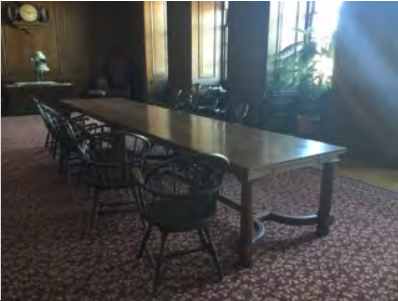
Knee or toe clearance not provided	25"	Provide at least 1 work surface with 27" min. knee and toe clearance.	1	350	\$350

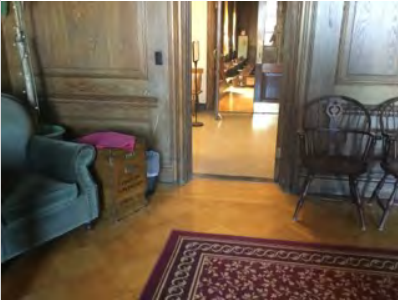
64	Town Hall, Lyons Hearing Room	2		Doors, Doorways, & Gates	Meeting Room

Mat not securely attached	-	Secure the rug.	1	Labor	\$0
Access to Goods and Services												
65	Town Hall, Select Board's Office and Hearing Room	2		Signage	Designation

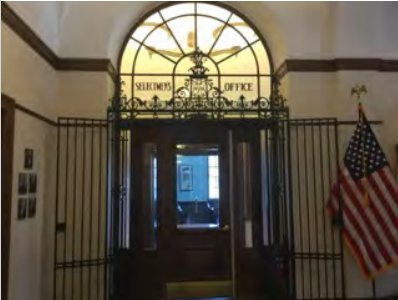
Raised characters not provided Braille not provided	- -	Provide text with raised characters duplicated in braille.	1	116	\$116

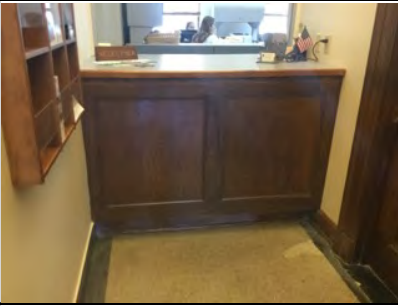
ID	Location	Floor	Room	Element	Type	Photo	Issues	Current Measure	Recommendations	Quantity	Price	Cost Estimation
66	Town Hall, Select Board's Office and Hearing Room	2		Service Counter	N/A

Counter > 36" high	42.5"	Provide a counter that is 36" max. above the ground or finished floor.	1	440	\$440
67	Town Hall, Select Board's Office and Hearing Room	2		Operable Parts	Other

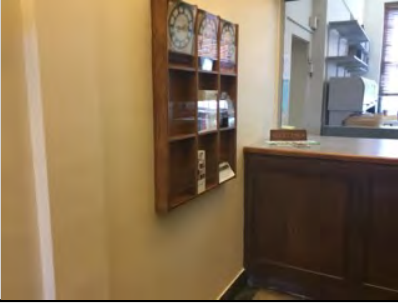
Reach < 15" or > 48"(forward/side approach)	68.75"	Relocate texts on upper shelves between 15"-48" above finished floor.	1	Labor	\$0
Access to Goods and Services												
68	Town Hall, Town Clerk and Registrar of Voters	2		Signage	Designation

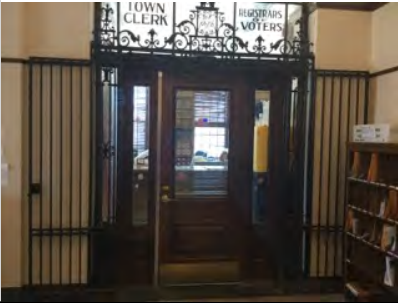
Raised characters not provided Braille not provided	- -	Provide text with raised characters duplicated in braille.	1	116	\$116
69	Town Hall, Town Clerk and Registrar of Voters	2		Service Counter	N/A

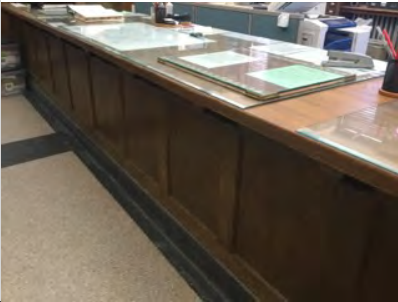
Counter > 36" high	40"	Provide a counter that is 36" max. above the ground or finished floor.	1	440	\$440

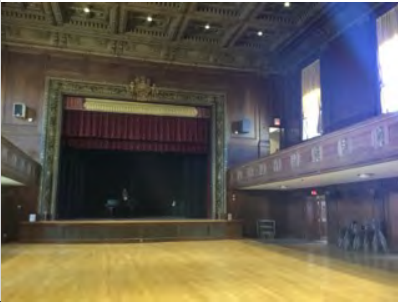
Access to Goods and Services												
70	Town Hall, Auditorium	2		Assembly Area	N/A

Assistive listening devices not provided	620	If audible communication is integral to the use of the space, provide an assistive listening system.	1	6250	\$6250

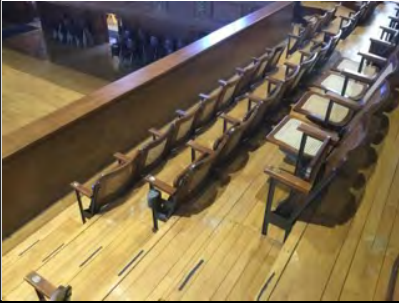
ID	Location	Floor	Room	Element	Type	Photo	Issues	Current Measure	Recommendations	Quantity	Price	Cost Estimation
Access to Goods and Services												
71	Town Hall, Auditorium Balcony	2		Assembly Area	N/A

Designated aisle seats < 5%	80	At least 5% of the total number of aisle seats provided must be identified by a sign or marker and have folding or retractable armrests.	4	450	\$1800
72	Town Hall, Auditorium Balcony	2		Assembly Area	N/A

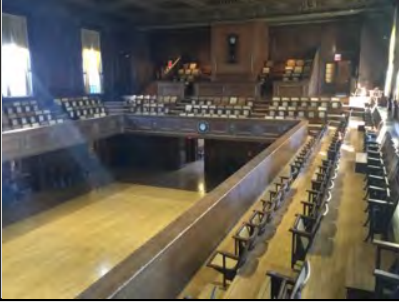
Number of seats Number of designated wheelchair spaces Minimum # wheelchair spaces not provided	262 0 -	For the short-term, ensure 5 accessible spaces and companion seating are provided on the first floor. For the long-term, undertake a feasibility study about providing 5 accessible spaces alongside fixed seats in the balcony.	5	TBD	\$0
Best Practice												
73	Annex, Inaccessible Stepped Entrance to Town Manager Purchasing Web Master, and Human Resources	2 3

*IHCD recommends a study to determine if it is feasible to install wheelchair and companion spaces in the auditorium balcony.

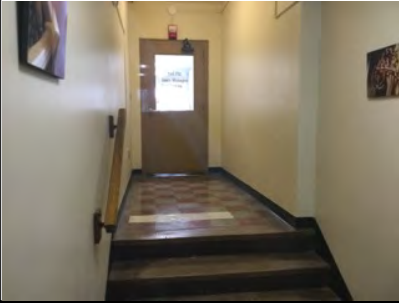
Stair: Consider providing a handrail on both sides.	2		\$0

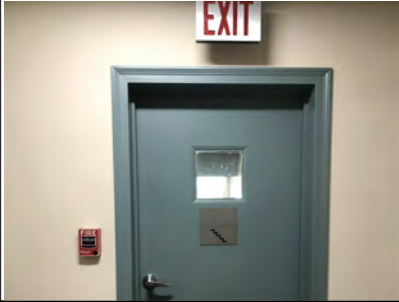
Access to Goods and Services												
74	Annex, Egress Stairs	2, 3		Signage	Egress

Braille not provided Sign not located on the latch side of the door		Provide braille. Locate sign at permanent rooms alongside the door on the latch side.	2	116 Labor	\$232
Access to Goods and Services												
75	Annex, Inaccessible Entrance to Town Manager Purchasing Web Master and Human Resources	2, 3		Signage	Designation

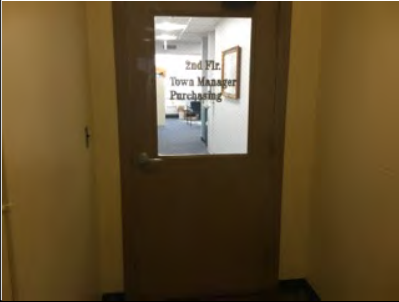
Raised characters not provided Braille not provided		Provide text with raised characters duplicated in braille.	2	116	\$232

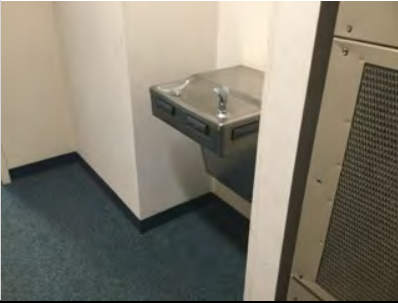
ID	Location	Floor	Room	Element	Type	Photo	Issues	Current Measure	Recommendations	Quantity	Price	Cost Estimation
Additional Access												
76	Annex, Near Rear Elevator	3		Drinking Fountains	Low

No drinking fountain provided for standing users	-	Provide an additional drinking fountain for standing users or install a Hi-Lo drinking fountain.	1	2014	\$2014
Access to Goods and Services												
77	Annex, Personnel Office	3		Service Counter	N/A

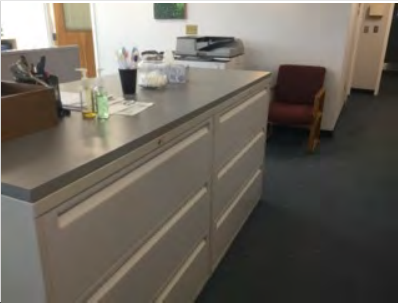
Counter > 36" high	40"	Provide a counter that is 36" max. above the ground or finished floor.	1	440	\$440
Access to Goods and Services												
78	Annex, Toilet Room Across From Credit Union	3		Doors, Doorways, & Gates	Toilet Room

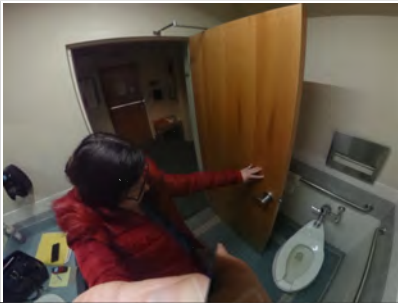
Maneuvering clearance(s) not provided	-	Provide an automatic door opener.	1	1530	\$1530
Toilet & Bathing Rooms												
79	Annex, Toilet Room Across From Credit Union	3		Single-User Toilet	N/A

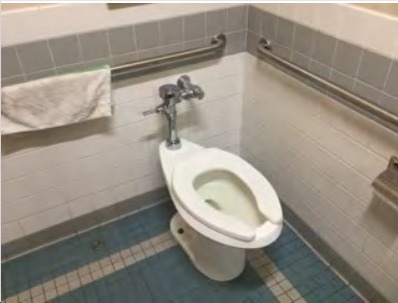
Centerline < or > 18" (MAAB)	18.5"	Centerline is not compliant but is usable.	1	-	\$0

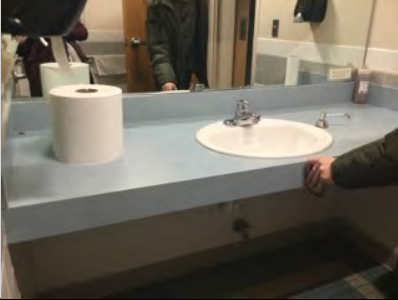
80	Annex, Toilet Room Across From Credit Union	3		Lavatory	N/A

Dispensers not within reach range	46", 51"	Relocate the soap dispenser and paper towel dispenser to 42" max. above the floor.	2	353	\$706

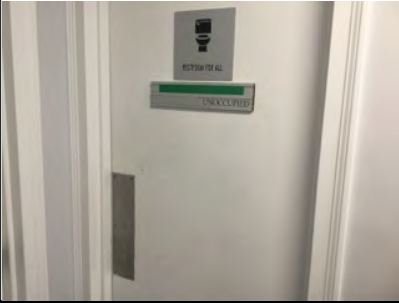
ID	Location	Floor	Room	Element	Type	Photo	Issues	Current Measure	Recommendations	Quantity	Price	Cost Estimation
Access to Goods and Services												
81	Annex, Toilet Room in Human Resources Department	3		Signage	Designation

. Sign not located on the latch side of the door Directional sign to access. toilet not provided	- -	Locate sign at permanent rooms alongside the door on the latch side. Provide a sign indicating the location of the nearest accessible toilet room.	1	Labor 116	\$116
Access to Goods and Services												
82	Annex, Veteran's Services	3		Doors, Doorways, & Gates	Office

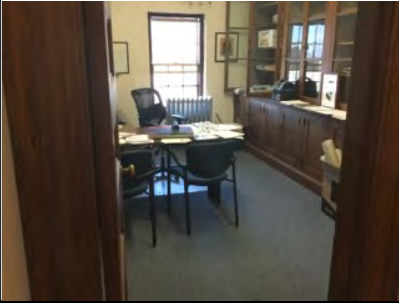
Clear width at door < 32"	29"	Widen the door so that there is 32" min. clear width.	1	1683	\$1683
Access to Goods and Services												
83	Town Hall, Stairways by Stage	3		Stairways	Interior

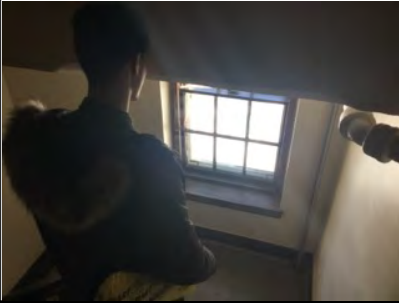
Minimum vertical clearance not provided	62"	Providing the 80" high vertical clearance minimum may be technically infeasible. Consider adding signage that says, "Low Headroom" or, "Low Ceiling".	2	116	\$232

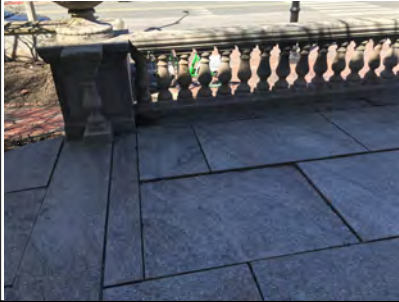
Approach and Entrance												
84	Accessible Route to Front Entrance by the Sloped Walkway	Ext.		Exterior Access Route	Exterior

Level changes > 1/4"	-	Alter changes in level to be 1/4" high max. on the stone walkway.	1	Labor	\$0

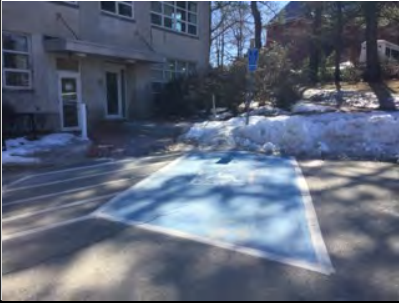
ID	Location	Floor	Room	Element	Type	Photo	Issues	Current Measure	Recommendations	Quantity	Price	Cost Estimation
Best Practice												
85	Exterior Route Improvement, Accessible Route Between the Town Hall and Annex	Ext.

Exterior Route Improvement: In order for a person who cannot navigate stairs to get into the Annex they must go outside the building and enter a different entrance. Consider providing a covered connector in this area.	1		\$0
Best Practice												
86	Exterior Route Improvement, Town Hall, Route Between the Front Entrance and Annex Entrance	Ext.

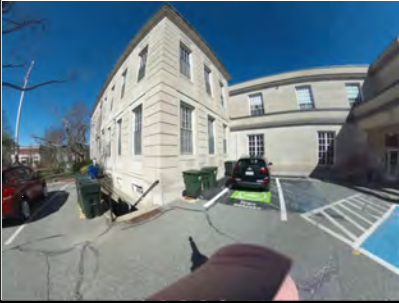
Exterior Route Improvement: Consider providing a clear and safe pedestrian walkway in the parking lot on the route between the main entrance to the Town Hall and west Town Hall entrance and Annex entrance.	1		\$0
Approach and Entrance												
87	Garden Walkway by Exit	Ext.		Exterior Access Route	Walkway

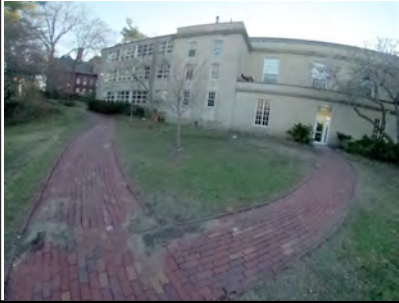
Surface openings > 1/2" Surface is not stable, firm, and slip-resistant		Repair deteriorated parts of the brick walkway. (Cost estimate for a 5' by 5' area.)	1	400	\$400

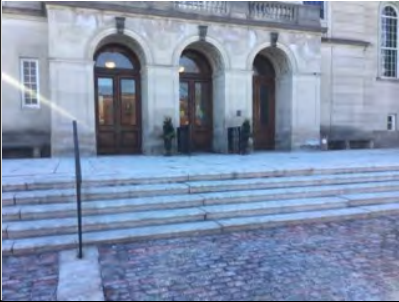
Best Practice												
88	Main Entrance, Town Hall	Ext.

32.5" -	Stairs: Consider providing compliant handrails at the main entrance 34"- 38" high above the ground; and providing handrail extensions.	2		\$0

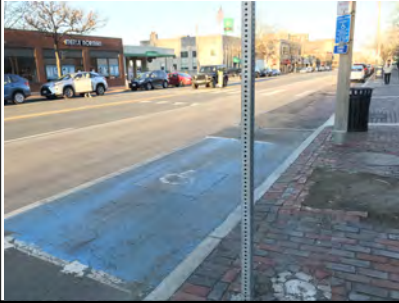
ID	Location	Floor	Room	Element	Type	Photo	Issues	Current Measure	Recommendations	Quantity	Price	Cost Estimation
Approach and Entrance												
89	Massachusetts Avenue Accessible Street Parking Space	Ext.		Exterior Access Route	Sidewalk

Curb ramp not provided Surface is not stable, firm, and slip-resistant Route not maintained in operable working condition		Provide a curb ramp by the parking space. Repair the brick and ensure that the accessible route is maintained in operable working condition. (Cost estimate for re-leveling a portion of the brick sidewalk and for providing a concrete curb ramp.)	1	1675	\$1675
Best Practice												
90	Massachusetts Avenue Crosswalk by Main Entrance	Ext.

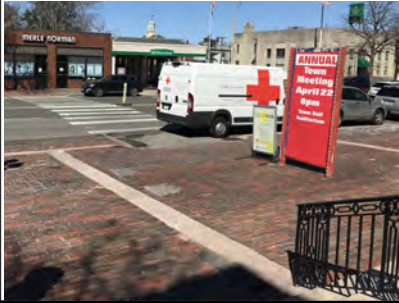
Detectable warnings are not provided on either side of the crosswalk directly in front of the main entrance on Massachusetts Avenue. Because it is not a state or federal road they are not required by the department of transportation, but It would be best practice to add them to alert blind and low vision pedestrians before they enter the street.	2		\$0

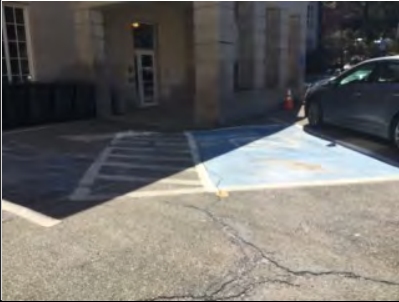
Access aisle not compliant		Restripe space and access aisle to comply with standards. Current striping is irregular and the access aisle does not extend the full length of the space.	1	150	\$150
Approach and Entrance												
92	Staff Parking Lot	Ext.		Off-Street Parking Lot or Garage	N/A

Total # of parking Total # of designated accessible parking spaces Total # of designated van accessible spaces Sign not provided Sign does not have the designation "Van Accessible"	- 2 0 - -	Provide a sign with the bottom of the sign 60" min. above the ground and the top 96" max. above the ground. Add the designation "Van Accessible" to the sign located at the van accessible space.	1	500	\$500

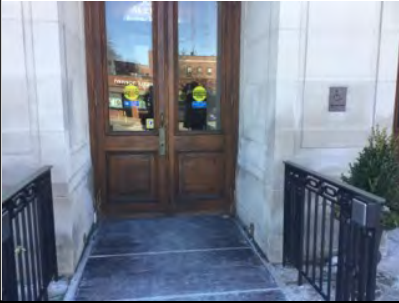
ID	Location	Floor	Room	Element	Type	Photo	Issues	Current Measure	Recommendations	Quantity	Price	Cost Estimation
Approach and Entrance												
93	Town Hall, Main Accessible Entrance	Ext.		Entrance	Main Entrance

Clear width at door is < 32"	25"	Provide an automatic door opener that opens both leaves simultaneously. (Cost estimate based on a new exterior automatic door opener.)	1	1350	\$1350
Best Practice												
94	Town Hall, Main Entrance	Ext.

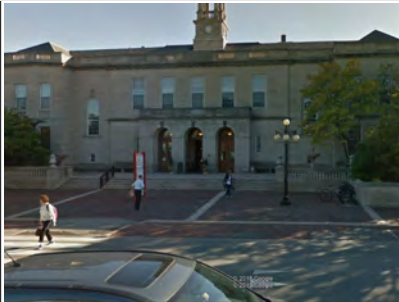
Wayfinding: The accessible route to the main entrance is not clear from the front of the building (It is located to the side behind a bike rack). Provide a directional sign at the base of the stair directing people to the accessible route on the west side.	1		\$0
Approach and Entrance												
95	Town Hall, Main Entrance Accessible Route	Ext.		Exterior Access Route	Walkway

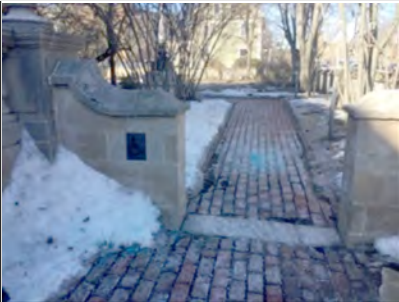
Surface openings > 1/2" Cross slope > 1:50 (2.00%) Level changes > 1/4" Route not maintained in operable working condition	- 3.4% - -	Renovate accessible route to main entrance to ensure that cross slopes do not exceed 1:50 (2.00%) and openings and level changes are not present. (Cost estimate is for an 80' long concrete walkway.)	1	1840	\$1840

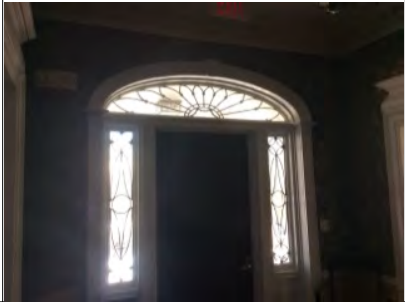
ID	Location	Floor	Room	Element	Type	Photo	Issues	Current Measure	Recommendations	Quantity	Price	Cost Estimation
Access to Goods and Services												
1	Emergency Exit	1		Means of Egress	N/A

Tactile exit sign not provided	-	Ensure tactile exit signs with raised characters and braille are provided at exit doors. Mount signs between 48"- 60" above finish floor located on the latch side of the door.	1	116	\$116
Access to Goods and Services												
2	Front Entrance	1		Means of Egress	N/A

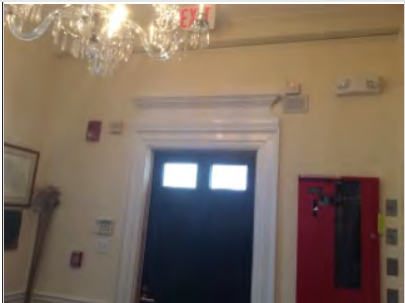
Tactile exit sign not provided	-	Ensure tactile exit signs with raised characters and braille are provided at exit doors. Mount signs between 48"- 60" above finish floor located on the latch side of the door.	1	116	\$116
Access to Goods and Services												
3	Front Service Desk, Toilet Room	1		Signage	Designation

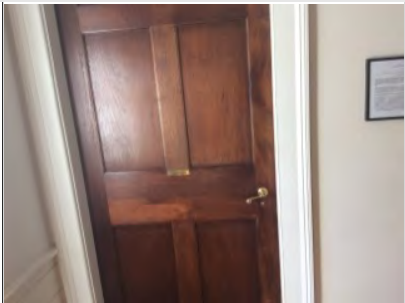
Not provided		Locate signage alongside the door on the latch side.	1	116	\$116

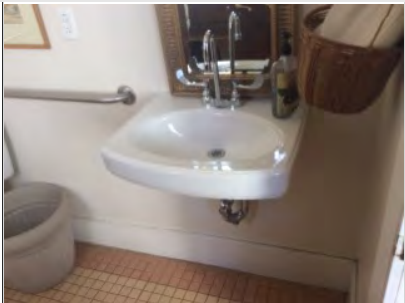
Toilet & Bathing Rooms												
4	Front Service Desk, Toilet Room	1		Lavatory	N/A

Plumbing underneath is exposed		Insulate or otherwise configure pipes to prevent contact at lavatory.	1	46	\$46

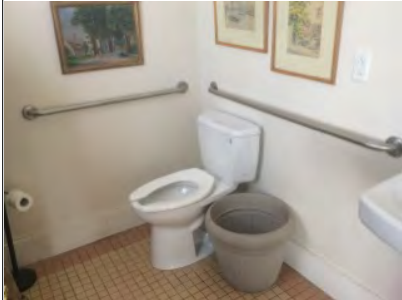
ID	Location	Floor	Room	Element	Type	Photo	Issues	Current Measure	Recommendations	Quantity	Price	Cost Estimation
5	Front Service Desk, Toilet Room	1		Single-User Toilet	N/A

Flush control not on open side	-	Relocate the flush control to the open side.	1	187	\$187
Access to Goods and Services												
6	Meeting Room	1		Dining or Work Surfaces	Work Surface

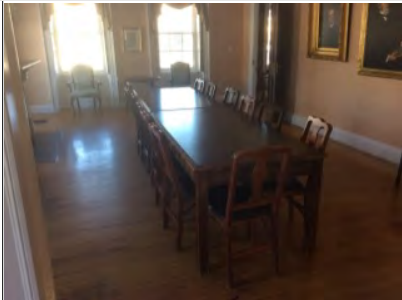
Knee or toe clearance not provided	24"	Provide at least 1 work surface with 27" min. knee and toe clearance.	1	500	\$500
Access to Goods and Services												
7	Route To Main Entrance	1		Interior Access Route	N/A

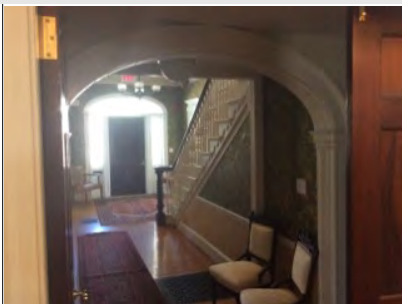
Obstructed by protruding objects	77"	It may be technically infeasible to address this low clearance.	1		\$0
Access to Goods and Services												
8	Side Exit	1		Means of Egress	N/A

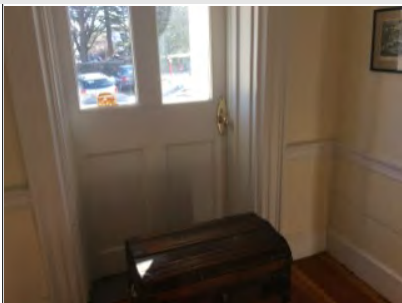
Tactile exit sign not provided	-	Ensure tactile exit signs with raised characters and braille are provided at exit doors. Mount signs between 48"- 60" above finish floor located on the latch side of the door.	1	116	\$116

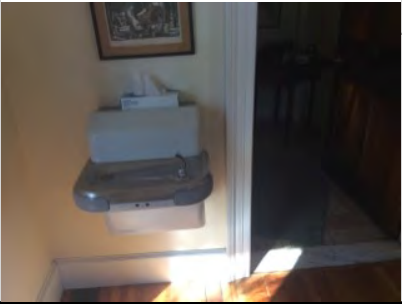
ID	Location	Floor	Room	Element	Type	Photo	Issues	Current Measure	Recommendations	Quantity	Price	Cost Estimation
Additional Access												
9	Side Exit, Drinking Fountain	1		Drinking Fountains	N/A

No drinking fountain provided for standing users	-	Provide an additional drinking fountain for standing users.	1	2014	\$2014
Access to Goods and Services												
10	Side Exit, Toilet Room	1		Signage	Designation

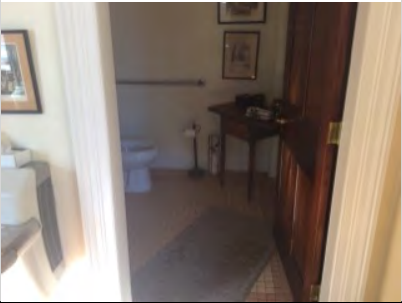
Not provided	-	Locate signage alongside the door on the latch side.	1	116	\$116
Toilet & Bathing Rooms												
11	Side Exit, Toilet Room	1		Single-User Toilet	N/A

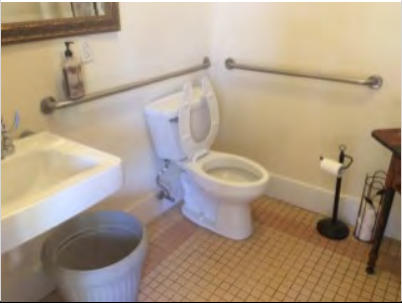
Clearance at toilet < 72" clear depth	-	Relocate furniture to provide clear floor space that is 72" deep min. at the toilet.	1	Labor	\$0
12	Side Exit, Toilet Room	1		Lavatory	N/A

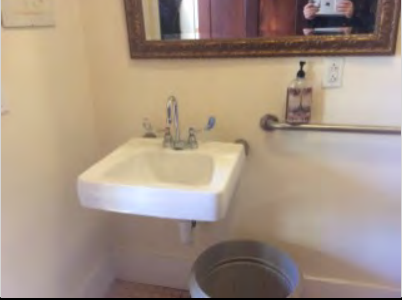
Mirror above lavatory w/reflective surface > 40"	50"	Lower mirror so that the bottom surface is at 40" max. above finish floor.	1	128	\$128

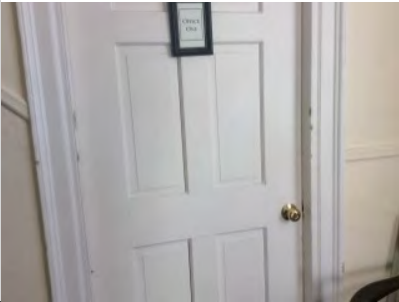
ID	Location	Floor	Room	Element	Type	Photo	Issues	Current Measure	Recommendations	Quantity	Price	Cost Estimation
Access to Goods and Services												
13	Offices 1 & 2	2		Signage	Designation

Raised characters not provided Braille not provided Sign not located on the latch side of the door	-	Provide text with raised characters duplicated in braille. Locate sign at permanent rooms alongside the door on the latch side.	1	116	\$116
Access to Goods and Services												
14	Toilet Room	2		Doors, Doorways, & Gates	N/A

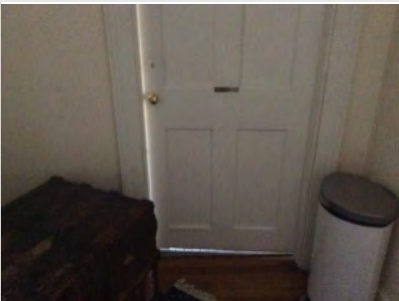
Hardware not operable with a closed fist		Provide hardware that can be operable with one hand and not require tight grasping, pinching, or twisting of the wrist.	1	242	\$242
15	Toilet Room	2		Signage	Designation

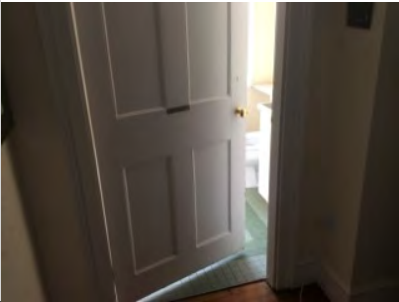
Not provided	-	Locate signage alongside the door on the latch side.	1	116	\$116
Access to Goods and Services												
16	Counseling Room	3		Doors, Doorways, & Gates	Other

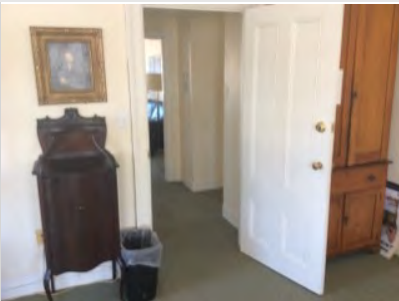
Hardware not operable with a closed fist		Provide hardware that can be operable with one hand and not require tight grasping, pinching, or twisting of the wrist.	1	242	\$242

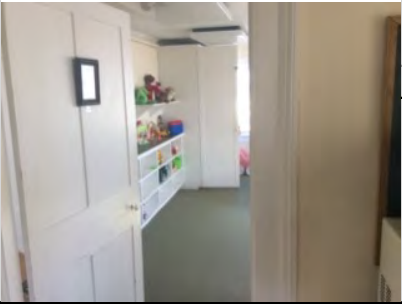
ID	Location	Floor	Room	Element	Type	Photo	Issues	Current Measure	Recommendations	Quantity	Price	Cost Estimation
Access to Goods and Services												
17	Counseling Room 2	3		Signage	Designation

Raised characters not provided Braille not provided Sign not located on the latch side of the door	-	Provide text with raised characters duplicated in braille. Locate sign at permanent rooms alongside the door on the latch side.	1	116	\$116
Access to Goods and Services												
18	Counseling Room Emergency Exit	3		Doors, Doorways, & Gates	Emergency Egress

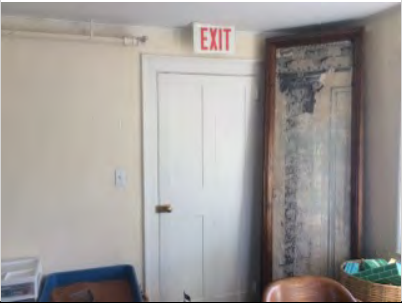
Hardware not operable with a closed fist	-	Provide hardware that can be operable with one hand and not require tight grasping, pinching, or twisting of the wrist.	1	242	\$242
Access to Goods and Services												
19	Emergency Exit 3rd Floor Counseling Room	3		Means of Egress	N/A

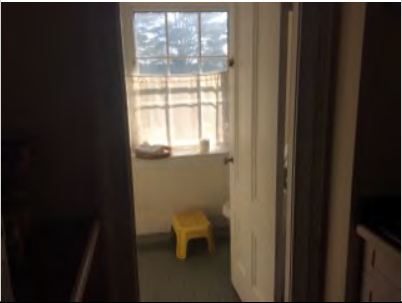
Access to Goods and Services												
20	Toilet Room	3		Signage	Designation

Not provided	-	Locate signage alongside the door on the latch side.	1	116	\$116

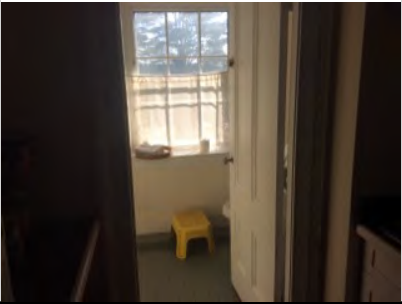
ID	Location	Floor	Room	Element	Type	Photo	Issues	Current Measure	Recommendations	Quantity	Price	Cost Estimation
Access to Goods and Services												
21	Toilet Room	3		Doors, Doorways, & Gates	Toilet Room

Hardware not operable with a closed fist	27"	Provide hardware that can be operable with one hand and not require tight grasping, pinching, or twisting of the wrist.	1	242	\$242
Approach and Entrance												
22	Accessible Space	Ext.		Off-Street Parking Lot or Garage	Visitor

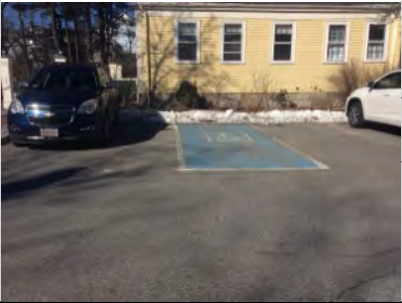
Total # of parking Total # of designated accessible parking spaces Total # of designated van accessible spaces Access aisle < 96" wide at van space Sign not provided	24 1 0 50" -	Convert the existing accessible space into a van accessible space. Provide a marked access aisle that is at least 96" wide. Provide a sign with the bottom of the sign 60" min. above the ground and the top 96" max. above the ground. Ensure the sign has the designation "Van Accessible."	1	400	\$400

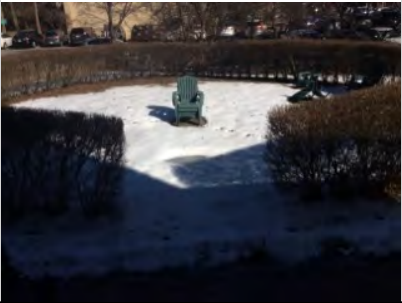
Best Practice												
23	Grass Area by Rear Exit	Ext.

Consider providing accessible tables in this area.	1		\$0
Play and Sport Areas												
24	Playground	Ext.		Play Areas	N/A

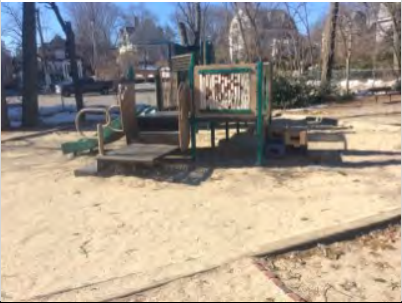
Accessible route not provided to ground level play components		Ensure an accessible route is provided to one of each type of ground level play components. Cost estimate for 25-foot long stone dust route to the playground and 750-square-foot poured in place rubber surface at playground structure.	1	10785	\$10785

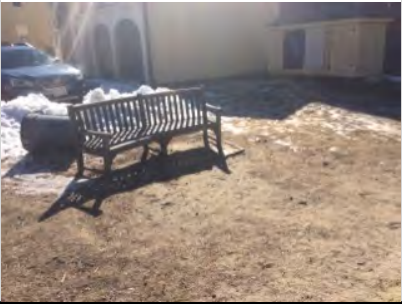
ID	Location	Floor	Room	Element	Type	Photo	Issues	Current Measure	Recommendations	Quantity	Price	Cost Estimation
Best Practice												
25	Playground Area	Ext.

No accessible route to 20% of benches	-	Consider providing an accessible route to one bench and providing a level space beside the bench so that a wheelchair user can sit alongside someone seated on the bench.	1		\$0
Access to Goods and Services												
26	Rear Exit	Ext.		Doors, Doorways, & Gates	Emergency Egress

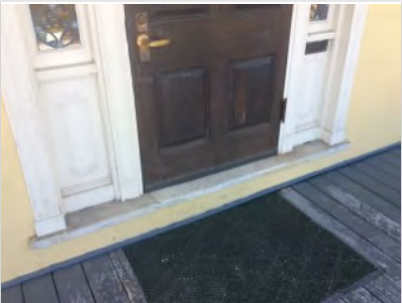
Threshold > 1/2" high	9"	It may be technically infeasible to provide access to this porch because of the limited space.	1		\$0
Access to Goods and Services												
27	Rear Exit Porch	Ext.		Dining or Work Surfaces	Dining Surface

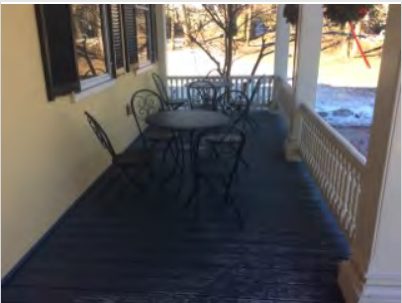
At least one or 5% accessible tables not provided Not on a accessible route	- 4	Provide an accessible picnic table on an accessible route.	1	700	\$700
Approach and Entrance

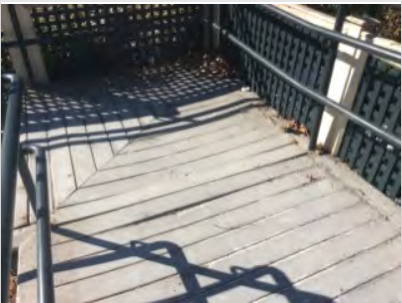
28	Route to the Accessible Entrance	Ext.		Exterior Access Route	Walkway

Surface is not stable, firm, and slip-resistant	-	Repair deteriorated boards on the accessible route.	1	1687	\$1687
